### Open Avionics with Beacon

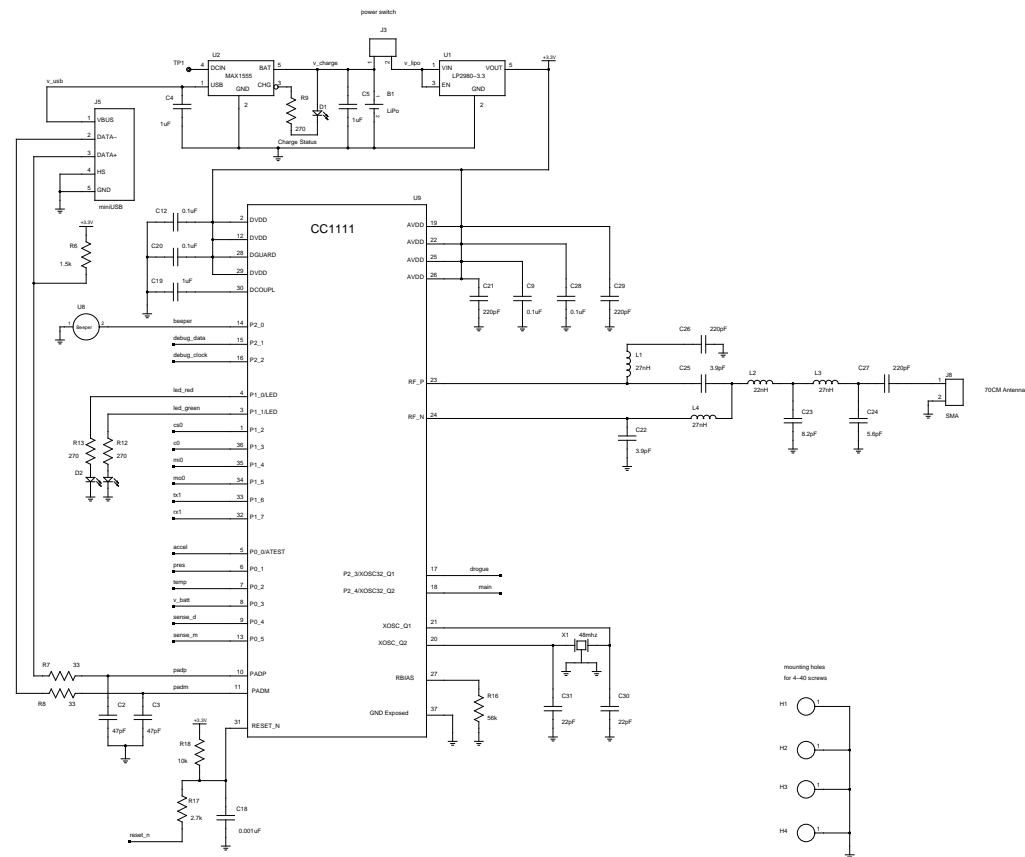
R18 shouldn't be necessary, but experience with a CP2103 GPO interface to the debug port suggests we may need a stiff pullup. Consider 10k in placeholder for experimentation since we have read boards in hand.
